Uniform Mitigation Verification Inspection Form

Inspection Date: 3/18/2015		
Owner Information		
Owner Name: Paradise Harbor Apartments, Inc.		Contact Person:
Address: 300 Golden Isles Drive		Home Phone: (954) 458-3294
City: Hallandale Beach	Zip: 33009	Work Phone:
County: Broward		Cell Phone:
Insurance Company: Citizens		Policy #:
Year of Home: 1962	# of Stories: 3	Email: vernireland@earthlink.net

Elevation Photos

300 Golden Isles Drive

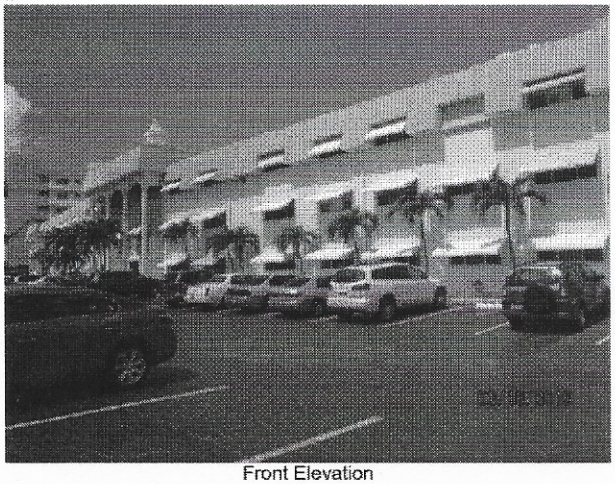
Front Elevation

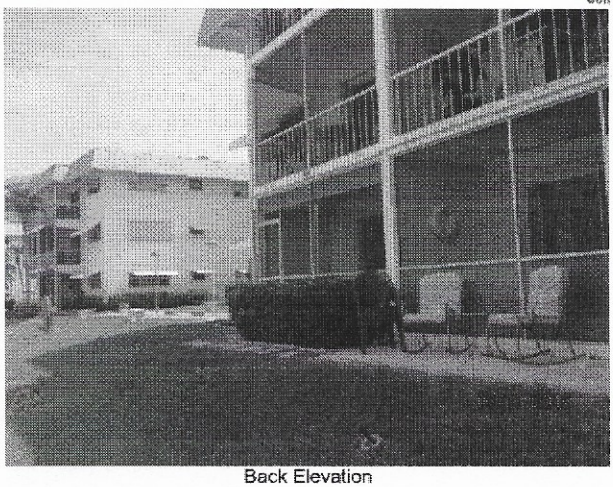
Back Elevation

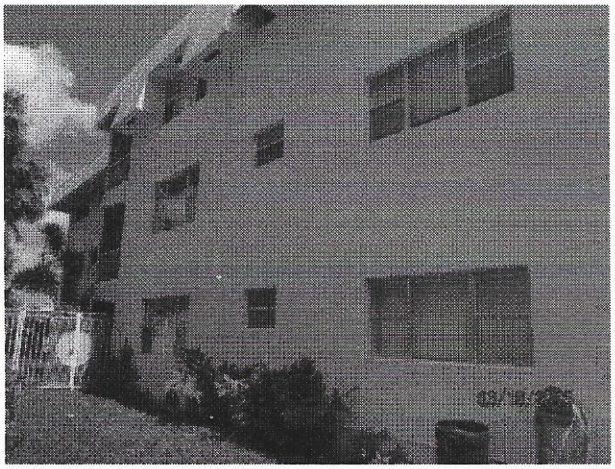
Left Elevation

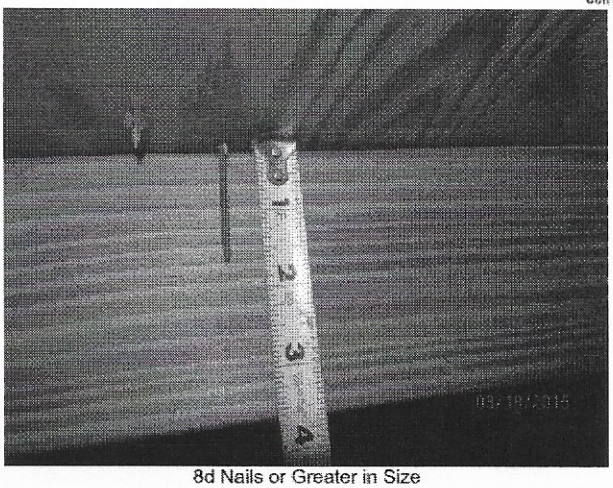
Built-Up/ Rolled Asphalt Roof Covering

8d Nails or Greater in Size

Roof Deck Attachment. Our report reveals that the roof deck is nailed with a combination of fasteners and/or a fastening pattern that can be upgraded. When the time comes to update the roof, ensure that the roofing professional refastens the existing roof deck (or installs the new one) with at least 8d ring-shank nails, spaced a minimum of every 6 inches, on every single truss or rafter throughout your attic.

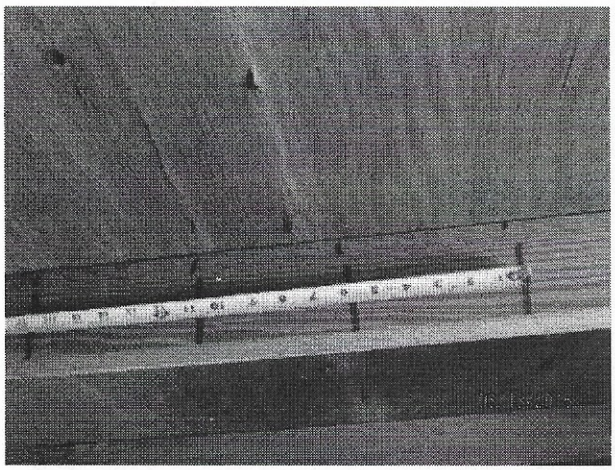
8d Nails or Greater in Size Spaced 6" Along the Edge

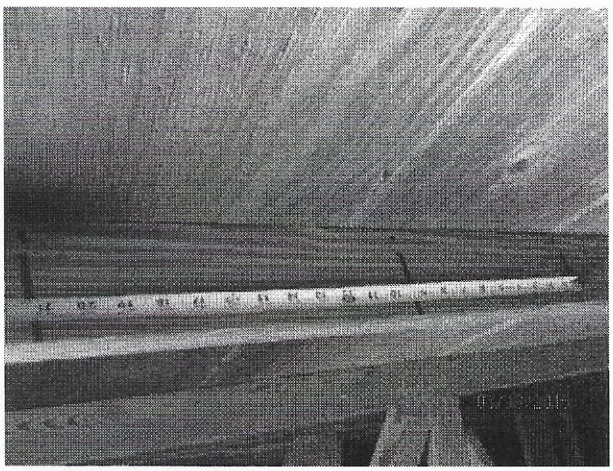
8d Nails or Greater in Size 12" in the Field

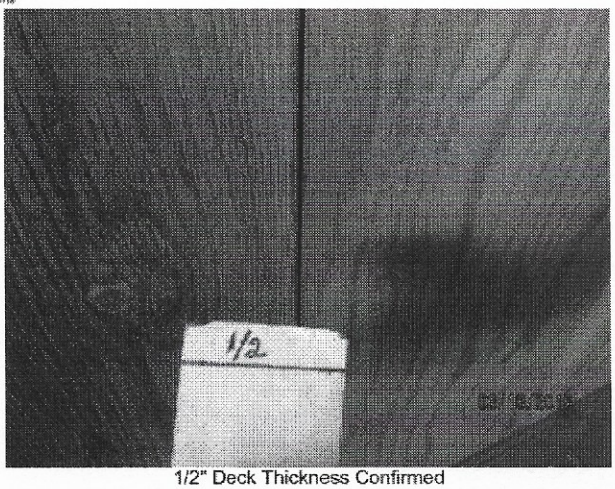
1/2" Deck Thickness Confirmed

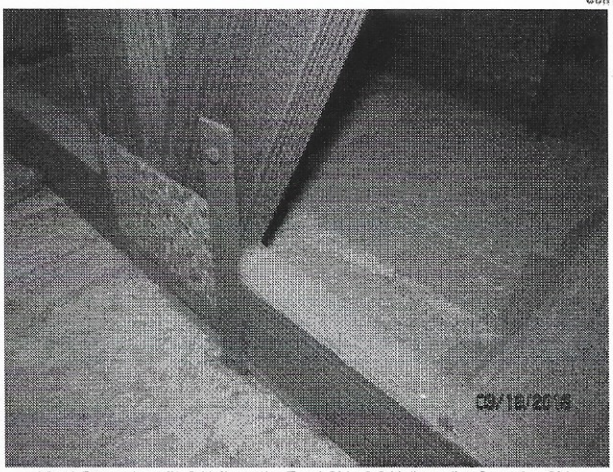
Metal Connector with 3 Nails on the Front Side & 0 Nails on the Opposing Side

Roof-to-Wall Attachment Our report indicates that the existing roof-to-wall attachment(s) do not meet the requirements on the Uniform Mitigation Verification Inspection form for Single Wrap Straps. This definition requires at least two nails on the front side and at least one on the other of every strap in the attic, on every truss or rafter. As it is often difficult to access every truss or rafter, the ideal time to upgrade this feature is when the roof deck is being replaced. In some circumstances, this work can be done on its own; consult a professional for details. Retrofits to existing roof to wall connections should be permitted with the local building department, and installations should follow the manufacturer's guidelines.

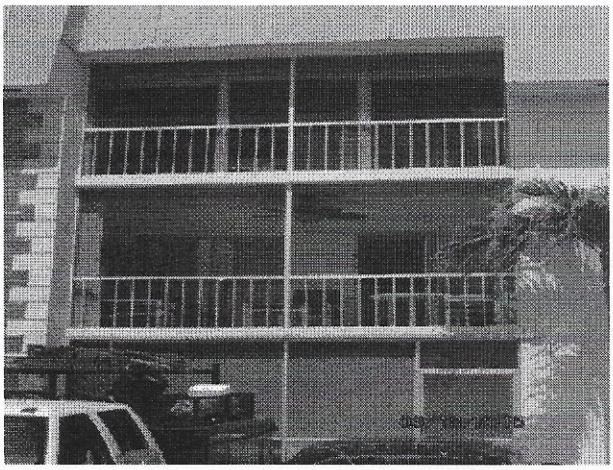
Non-Impact Rated Clamshell Awning Shutter

Unprotected Windows

Non-Impact Rated Roll Down Shutter

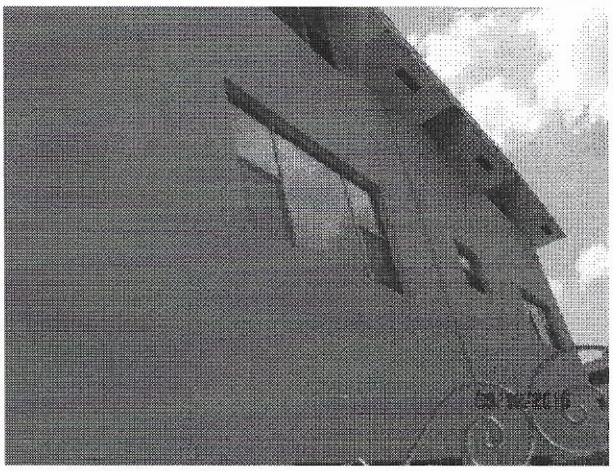
Unprotected Window

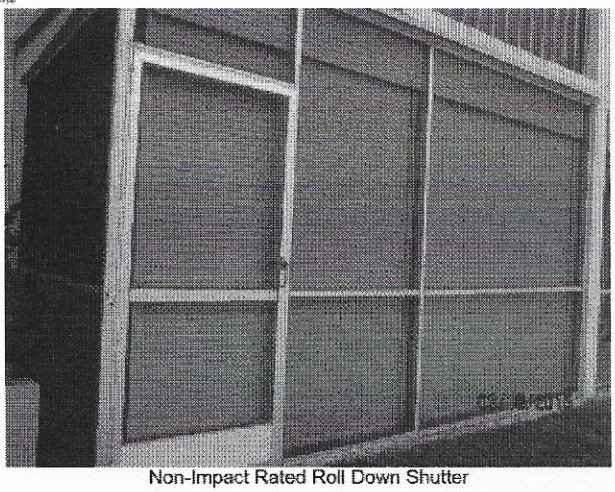
Non-Impact Rated Roll Down Shutter

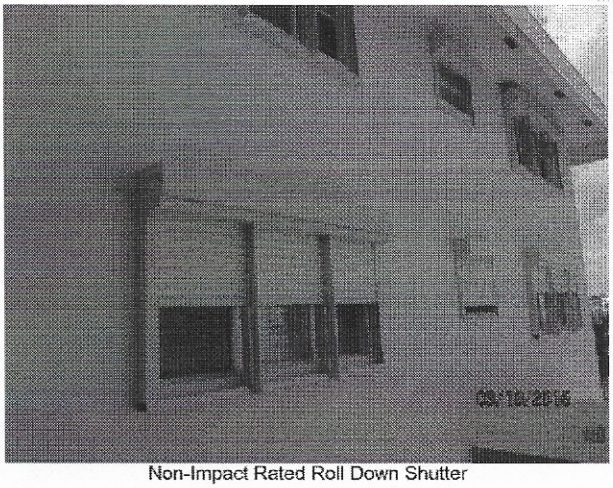
Non-Impact Rated Roll Down Shutter

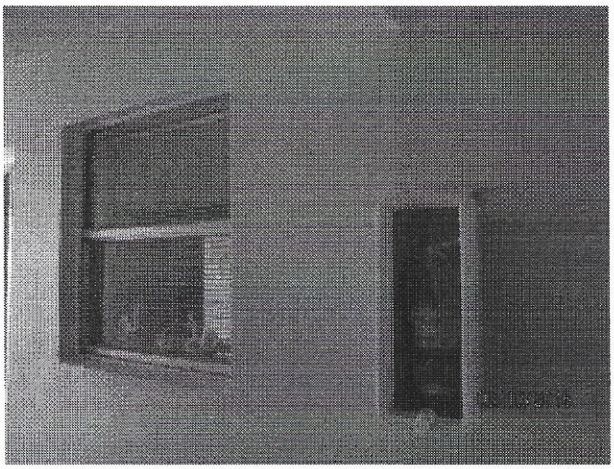
Unprotected Window
